MATERIALS AND RESEARCH DEPARTMENT
5900 FOLSOM BLVD., SACRAMENTO 95819

November 1970
M&R No. 636405-3
Final ReportMr. J. A. Legarra
State Highway Engineer

DYNAMIC TESTS OF AN
ENERGY ABSORBING BARRIER EMPLOYING
WATER-FILLED CELLS

SERIES XXI

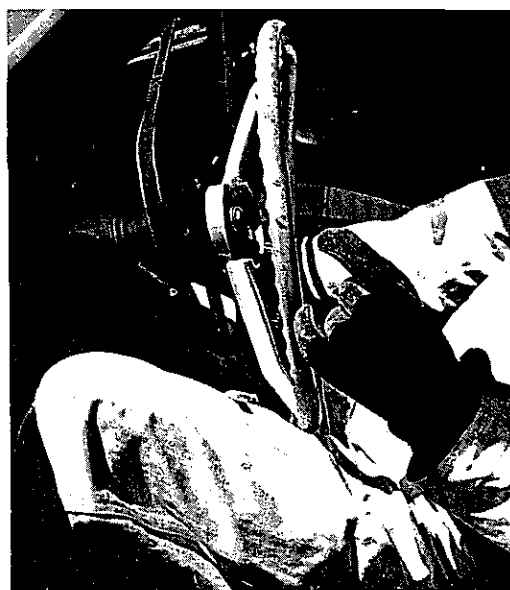
Figure 4

Results: See Plate 2 (page 14) for a summary of the test results. A 4680 lb. Dodge impacted the test barrier headon at a speed of 33.3 mph. The test vehicle did not stop quite as smoothly as it did for Test 211. Vehicle rise was 4-1/2 inches. Damage to the vehicle was moderate and included deformation of the grill, front bumper, and front of the hood (see Figure 2, below). The exhaust manifold was broken near its attachment to the engine block and the radiator was forced back into the V-belt lower pulley. The post behind the front door (removed for the test) on the drivers side failed at its connection with the roof (see Figure 3, below). The permanent deformation of the steering wheel was 2" (see Figure 4, below).

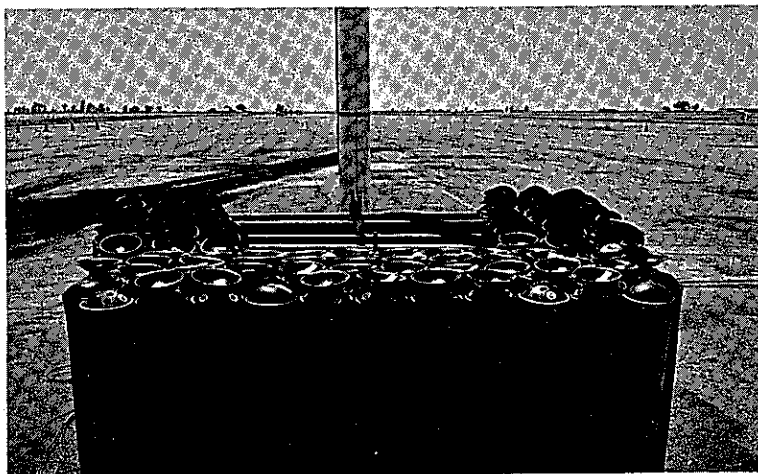
Figure 5

Only minor damage was sustained by the barrier (see Figure 5, below). Four evaporation caps were blown off water cells in the nose cluster and some crosby clips on the guide cable were jammed against the cable guide in diaphragm No. 5. The concrete backstop was shifted back one inch. Maximum vehicular displacement of the barrier was 8'-4"; the post impact location of the leading edge of the barrier was 6'-6" behind its pre-impact position. A total of 2250 lbs. of water was expelled from the cells.

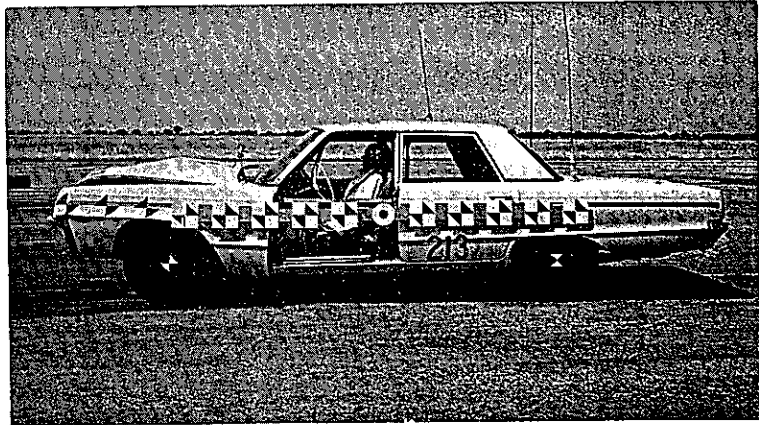
Figure 8

Results: See Plate 3 (page 18) for a summary of the test results. A 4600 lb. Dodge impacted the test barrier headon at a speed of 48.2 mph. During impact, the vehicle rode up on the barrier nose. Vehicle rise was 11 inches. The vehicle fan and radiator were jammed up against the engine block. There was severe damage sustained by the grill, front bumper, and front of the hood of the test vehicle (see Figure 7, below). The body of the vehicle was deformed over the door post and in front of the front door hinges on both sides, indicating a severe buckling failure of the vehicle chassis (see Figure 8, below). There was severe buckling of the right front fender

and minor buckling of the left front fender. There was moderate buckling of the floor board in the rear of the passenger compartment. The impact force of the dummy, restrained by both a lap belt and single diagonal shoulder harness, caused a 2-1/2 inch permanent deformation in the steering wheel. The driver's seat came loose on its guides although the guides remained firmly attached to the floorboard. There was some fraying of the shoulder harness near its connection to the lap belt. The vehicle was considered a total loss.

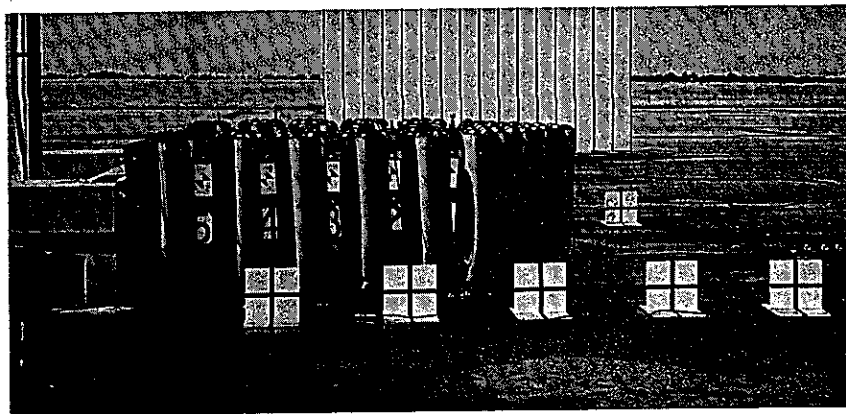
Figure 9

Barrier damage consisted of 26 orifice plugs ejected, a deformed "through" bolt at the left end of Diaphragm No. 6, splitting of the left end of the middle 6" x 6" timber on Diaphragm No. 6, and one broken pressure transducer (see Figure 9, below). Maximum vehicular displacement of the barrier was 12'-5". The post impact position of the leading edge of the barrier was 6'-2" behind its pre-impact location.

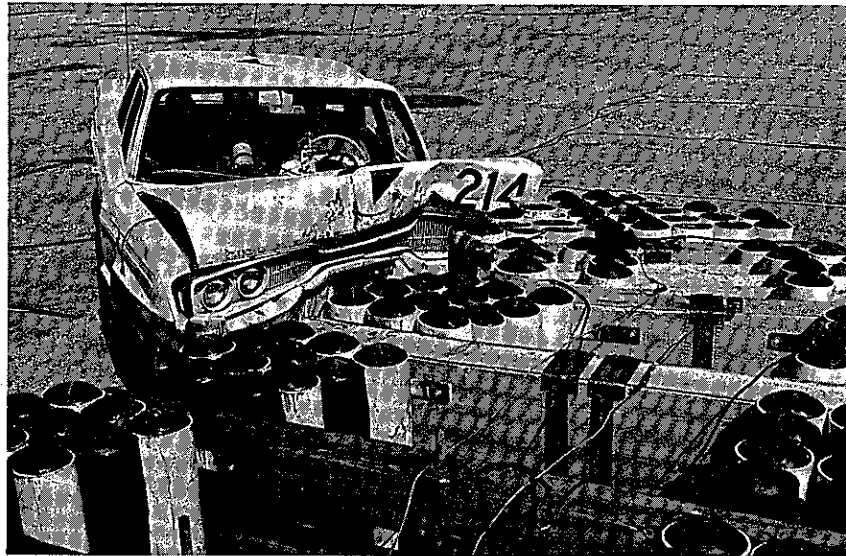
Figure 13

The barrier was twisted such that the center of the nose was displaced 3 ft. back and 2 ft. to the right of its original position (see Figure 13, below). Barrier damage consisted of separation between four pairs of cells, bending and crushing failures of Diaphragm Nos. 1, 2, and 3, splitting of spacer blocks in Diaphragms 4 and 5, failure of the legs of all three 5/8 inch plywood panels,

and failure of all the components of the "rigid" backstop. The most significant failure was of the center cable attachment to its front anchor. Slipping of the "dead" end of the cable through the cable clips was the cause of failure. Although the number and spacing of the clips was less than the industry's recommendations (due to the proximity of the barrier nose with the anchor), this same system sustained over 6000 lbs. of tensile load during Test 213. This cable failure did significantly alter the barrier performance after cable slip occurred. Also, the turnbuckle strain gage data indicates that the 4000 lb. cable preload was, for some unexplained reason, lost prior to impact. This also altered the barrier's resistance to upward movement.

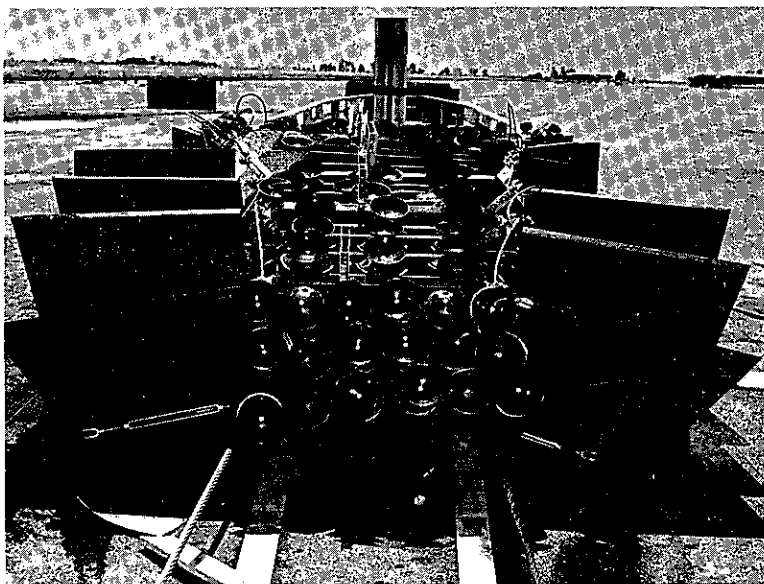
Figure 22

The barrier remained intact; however, some damage was sustained (see Figure 22, below). Many of the fender panels were scarred and most were damaged on the rear bottom corners where they were thrust into the ground as the barrier was compressed (see Figure 23, below). The edges of several diaphragms were broken or showed delamination of the plywood; hinges between fender panels and diaphragms were bent or broken in several locations. Damage was less severe towards the rear portion of the barrier. Interior panels were undamaged behind the void module (third section back of the nose). There was no damage to the steel backup structure. Barrier displacement was 9.3 feet.

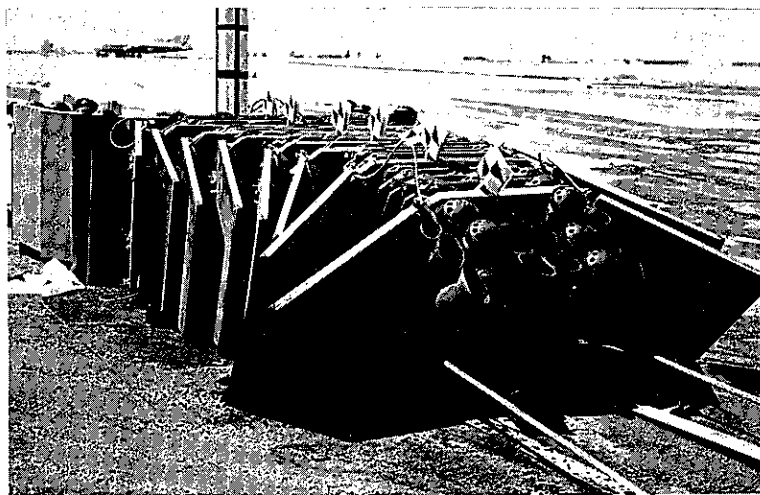
Figure 27

No barrier components were dislodged. Fender panels on the left side of the first three modules were scarred. Bottoms and/or top inserts were blown out of 16 water cells. The shear pins on the front secondary cables were sheared off. The barrier as a whole was translated straight back with negligible lateral movement or "buckling". Maximum vehicular displacement of the barrier was 16.3 feet but the permanent displacement of the barrier nose was only 10.7 feet (see Figure 27, below).

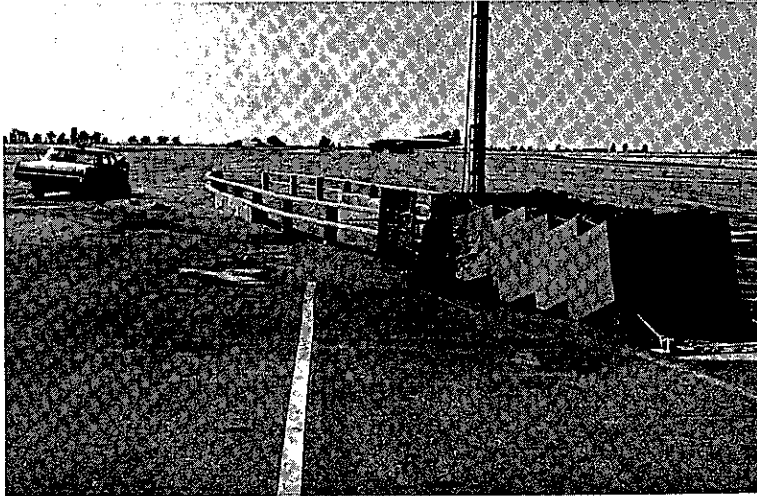
Figure 29

Several fender panels were torn off the barrier on the left side, mainly due to hinge failures. Two panels were thrown 8'-0" beyond the final position of the car and two panels were lodged in the crushed front end of the car. The five cells on the left side

of the bridge approach guardrail were all torn off and scattered along the path of the car. Shear pins in the secondary cables sheared off. Permanent displacement of the barrier nose was 1.5 feet (see Figures 29 and 30, below).

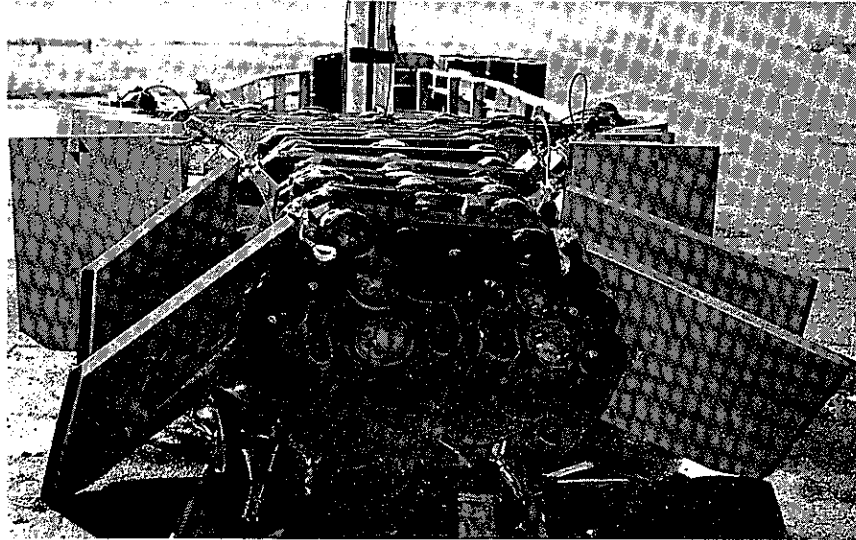
Figure 32

Maximum vehicular penetration was 15.3 feet and permanent displacement of the barrier nose was 11.7 feet. There was delamination and splitting of some of the interior panels and diaphragms, bent and broken hinges, and gouging of some of the fender panels; however, no parts became detached from the barrier (see Figure 32, below).
